Impact Damage Resistance of Carbon/Epoxy Composite Tubes for the DC-XA Liquid Hydrogen Feedline

NASA Technical Paper 3583

Marshall Space Flight Center • MSFC, Alabama

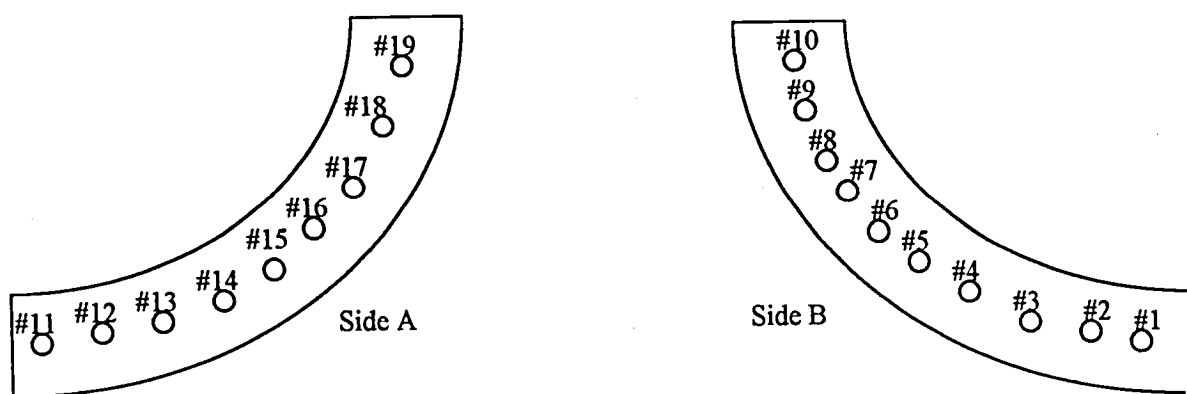
Figure 3. Location of impact sites for sharp impacts.

The tube was impacted 19 times at the sites shown in figure 3. Since the damage was highly localized, this large number of hits on one section of tubing was possible.

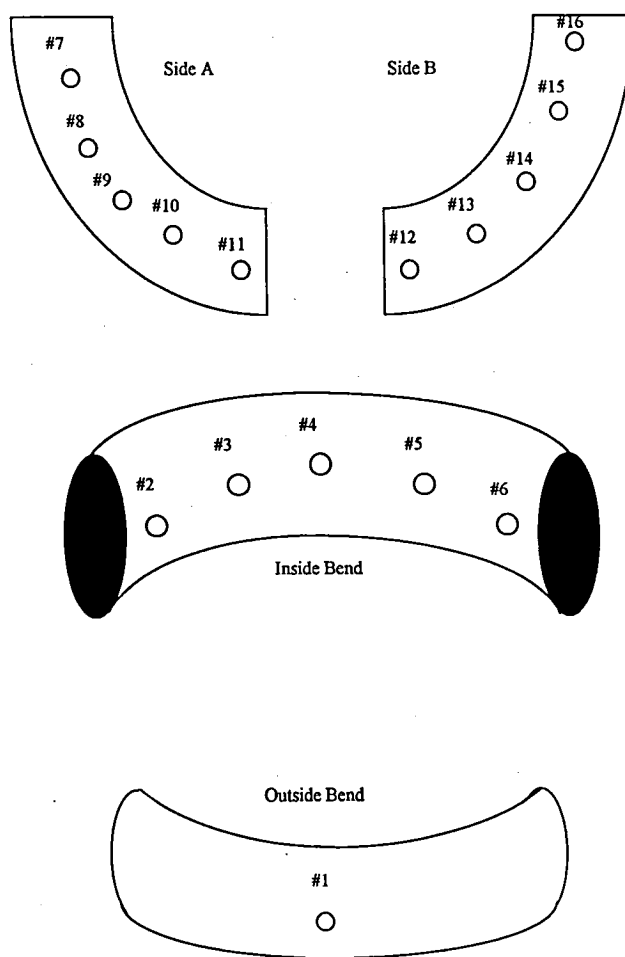
Figure 4. Impact sites for blunt impacts.

A second section of elbow tubing was impact tested using a 0.5-inch diameter semispherically ended rod that was considered a "blunt" type impact compared to the sharpened bolts and conical striker described in the previous section. A total of 16 impacts were conducted on this section of elbow as depicted in figure 4.

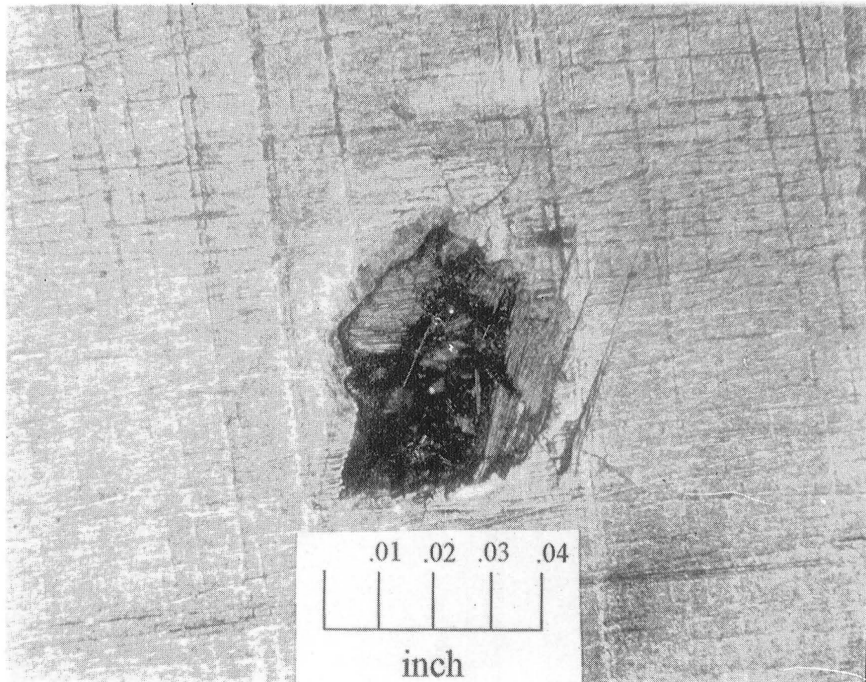
Hit No. 9

The surface damage can be seen in the cross-sectional photograph of hit No. 9. The typical conical region of damage observed in impact damaged composites can be seen in this, and most other, photomicrographs. This type of damage consists of heavy matrix damage below the impact site, with delaminations spreading out further away from this point as the specimen gets deeper.

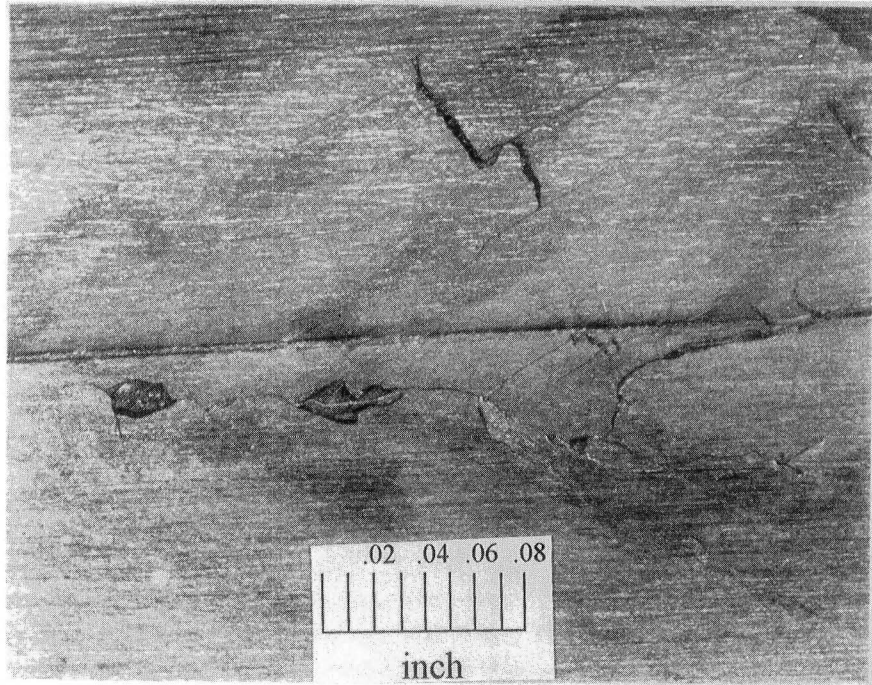
Hit No. 1

1. Surface Damage. Surface photomicrographs of the damage that caused leaks are given in appendix D. All of the photographs show matrix gel coat cracking in the region near the impact site with no localized damage present. This is due to the large diameter striker being used, which helps
